1. Survey No. CL-AS-010-020		2. Survey name: Mineral Water Resources of Excelsior Springs	
3. County: CL		4. Address (Street No.) 312	Street (name) E. Foley Street
5. City: Excelsior Springs	Vicinity: <input type="checkbox"/>	6. UTM: 15 S/ 394790.14E/4355575.05N	7. Township/Range/Section: T: 52N R: 30W S:1
8. Historic name (if known): Muriated Soda Spring		9. Present/other name (if known): W. W. Lesinger residence	
10. Ownership: <input checked="" type="checkbox"/> Private <input type="checkbox"/> Public		11a. Historic use (if known): HEALTH CARE/resort facility DOMESTIC/Single dwelling	11b. Current use: VACANT/not in use

42. Current owner/address: Villas Downtown, LP 1414 E Primrose ST STE 100 Springfield, MO 65804-4283	43. Form prepared by (name and org.): Deon Wolfenbarger Three Gables Preservation 320 Pine Glade Road, Nederland, CO Deon@threegables.net	44. Survey date: 2012
		45. Date of revisions:

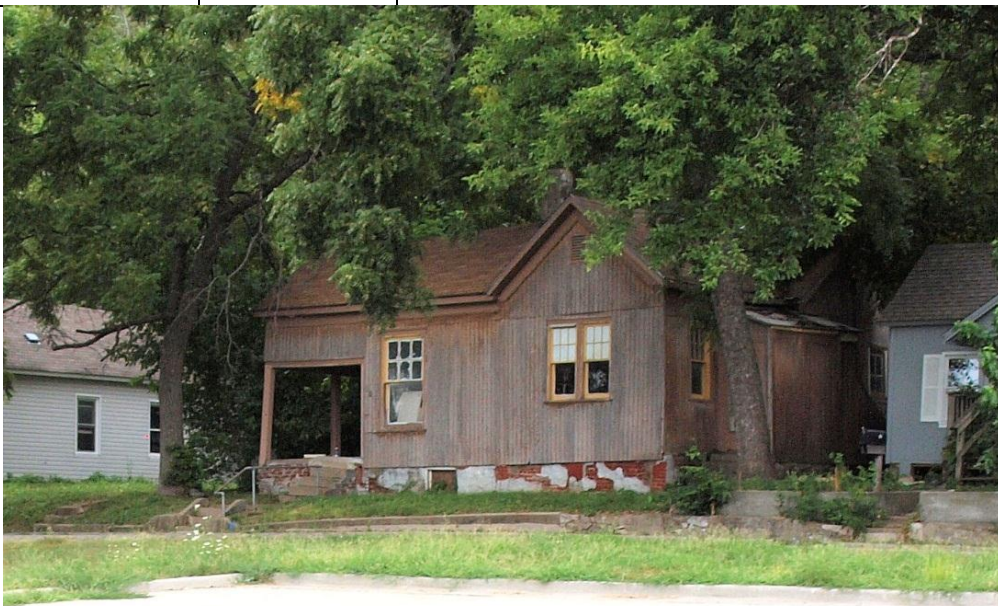
Photographer: Deon Wolfenbarger	Date: 7/29/2011	Description: Looking northwest at front (south) and east elevations
------------------------------------	--------------------	--

(the house was demolished during the course of this survey project – description is pre-demolition). This one-story cross-gable roof house has a porch on the west side which extends the west gable roof; the entry is on the west side of the house beneath the recessed porch. The siding is vertical plywood board panels. The brick foundation was covered with stucco which is failing, showing the brick beneath. A square bay window is on the east elevation. Windows are 6/1, and were broken at the time of the survey.
