1. Survey No. CL-AS-010-015		2. Survey name: Mineral Water Resources of Excelsior Springs	
3. County: CL		4. Address (Street No.) 215	Street (name) E. Broadway Avenue
5. City: Excelsior Springs	Vicinity: <input type="checkbox"/>	6. UTM: 15S/ 394703.32E/ 4355444.66N	7. Township/Range/Section: T: 52N R: 30W S:1
8. Historic name (if known): Excelsior Spring; Ettenson Block (building)		9. Present/other name (if known):	
10. Ownership: <input checked="" type="checkbox"/> Private <input type="checkbox"/> Public		11a. Historic use (if known): HEALTH CARE/resort facility; COMMERCE/business; specialty store	11b. Current use: VACANT/not in use

**HISTORICAL INFORMATION**

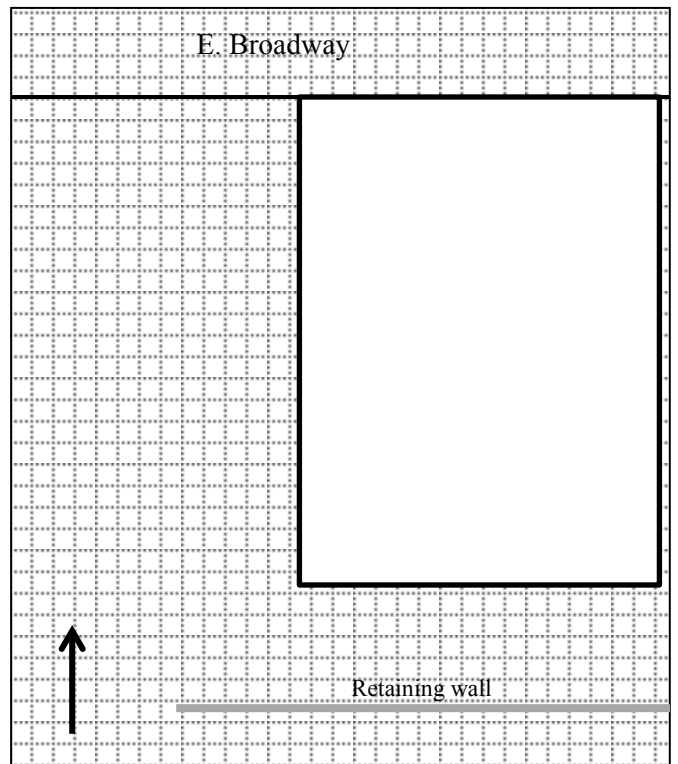
**SITE MAP/PLAN (include north arrow)**

Located on the south side of E. Broadway and immediately east of the Hall of Waters property, it is in a row of commercial buildings.

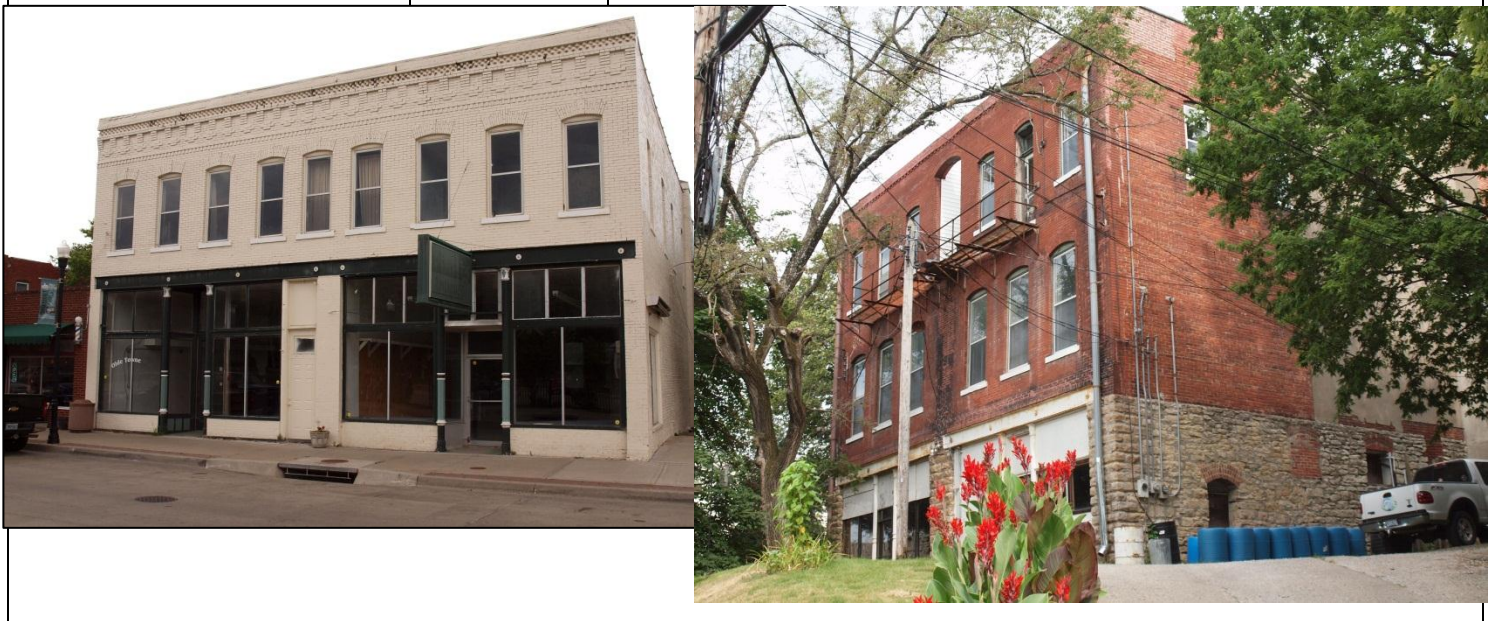
**PHOTOGRAPH**

Photographer: Deon Wolfenbarger	Date: 7/28/2011	Description: (left) Looking south onto north/front façade; (right) looking northwest onto south/rear & east elevations
------------------------------------	--------------------	---

The lot slopes down to the south, and the rear of the property (owned by the City) has a stone and concrete retaining wall with a small concrete block shed building (unknown if this structure is well-related). The main building on the parcel (described in previous survey) is a two-part commercial block masonry building with flat roof. Due to the change in elevation at the rear, the basement level is exposed as a full floor and features two "storefront" arrangements: one entry door for each half of the building flanked by display windows with transoms above. There are slender cast iron columns on the storefront door frames, and a I-bar serving as the sill divider between the basement and the first floor. An entry door leading to the second story is between the two storefronts. The upper story windows have radiating arch brick voussoirs, and the elaborate cornice at the top features decorative brick work forming faux brackets, beneath a double row of extended, alternating brick headers.
