1. Survey No. CL-AS-010-034		2. Survey name: Mineral Water Resources of Excelsior Springs	
3. County: CL		4. Address (Street No.) 528	Street (name) Caldwell Avenue
5. City: Excelsior Springs	Vicinity: <input type="checkbox"/>	6. UTM: 15 S/ 394443.72E/ 4355808.80N	7. Township/Range/Section: T: 52N R: 30W S:1
8. Historic name (if known): Sulphur Salt-Soda Spring		9. Present/other name (if known):	
10. Ownership: <input checked="" type="checkbox"/> Private <input type="checkbox"/> Public		11a. Historic use (if known): HEALTH CARE/resort facility	11b. Current use: DOMESTIC: single dwelling

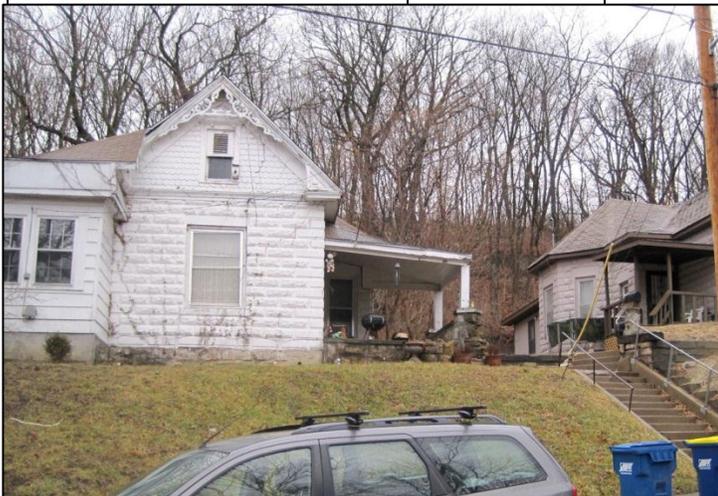
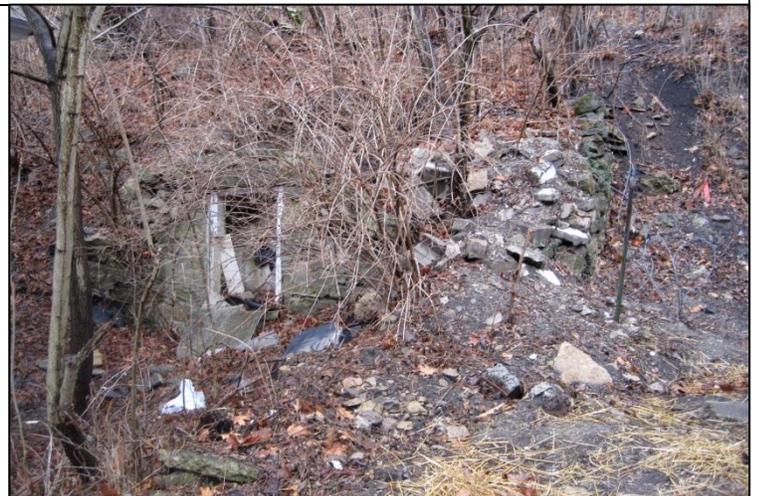
PHOTOGRAPH

Description:
(left) Looking west at east & north elevations & former pavilion site next to road; (right) looking northwest at east elevation, former pavilion site

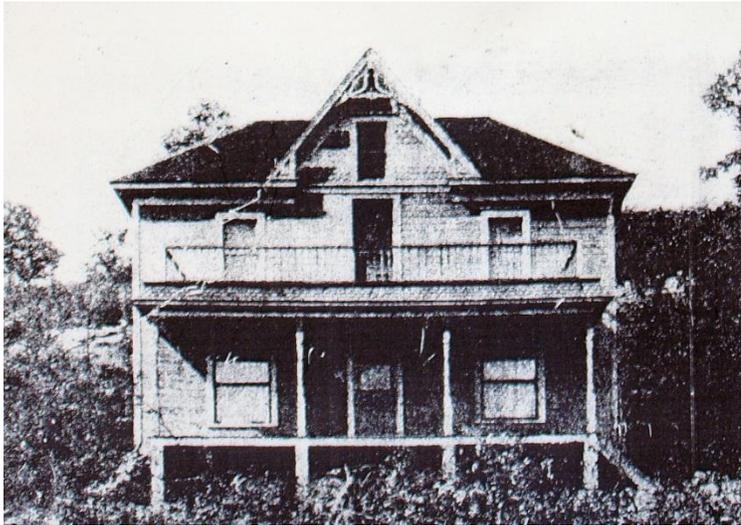
Historic photograph of building associated with Sulphur-Salt Soda Spring

The Sulphur Salt-Soda Springs was discovered in July 1906 at a depth of 126 feet. It was located in the Sunnyside addition, which was platted in 1904 (possibly indicating development of the area occurred immediately following platting). It was located just north of the Relief Spring on Caldwell Avenue; the historic photograph below shows the large two-story frame house that was purportedly associated with the spring [this house is no longer extant on Caldwell]. The waters belonged to the *Soda Bicarbonate* group, and purportedly could be drunk in generous quantities and had a general tonic effect on the entire system. Miss M. Bierman was the owner of the spring, and for the first few months after its discovery, it was offered free. However, the well does not show up on any historic maps or in the available city directories. In 1908, M. Bierman is not listed at any address on Caldwell, and both 526 and 528 Caldwell (north of Relief) were vacant. Oral interviews with residents revealed a well, recently filled in, at the back of 528 Caldwell; and one resident had heard that a larger boarding house was formerly at 528 Caldwell. Examination of the property indicated remnants of possible foundation for a larger building that may have predate the extant house. There are also extant historic foundations on the vacant lot to the south: the location of this well is thus an estimate of either 526 Caldwell (vacant) or 528 Caldwell (where the recently filled in well was merely a personal well serving the residents only).
