1. Survey No. CL-AS-010-020		2. Survey name: Mineral Water Resources of Excelsior Springs	
3. County: CL		4. Address (Street No.) 312	Street (name) E. Foley Street
5. City: Excelsior Springs	Vicinity: <input type="checkbox"/>	6. UTM: 15 S/ 394790.14E/4355575.05N	7. Township/Range/Section: T: 52N R: 30W S:1
8. Historic name (if known): Muriated Soda Spring		9. Present/other name (if known): W. W. Lesinger residence	
10. Ownership: <input checked="" type="checkbox"/> Private <input type="checkbox"/> Public		11a. Historic use (if known): HEALTH CARE/resort facility DOMESTIC/Single dwelling	11b. Current use: VACANT/not in use

42. Current owner/address: Villas Downtown, LP 1414 E Primrose ST STE 100 Springfield, MO 65804-4283	43. Form prepared by (name and org.): Deon Wolfenbarger Three Gables Preservation 320 Pine Glade Road, Nederland, CO Deon@threegables.net	44. Survey date: 2012
		45. Date of revisions:

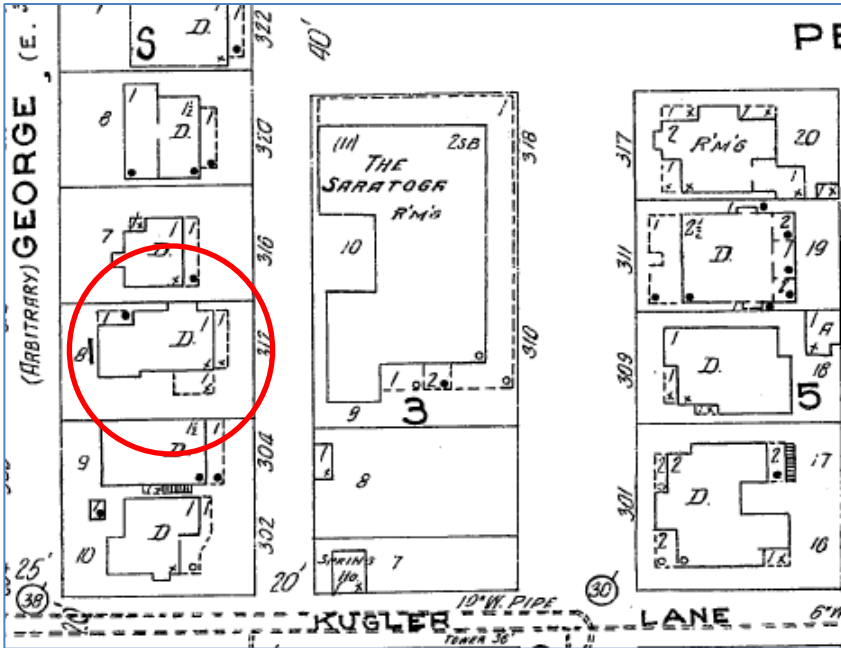
1926 Sanborn Map

The only historical record of the Muriated Soda Spring was a listing in the 1917 City Directory at 312 E. Foley: "W. W. Lesinger, Muriated Soda Well." The Sanborn maps do not show any spring house or pavilion, and the well is not listed in the 1922 City Directory, although Lesinger was still the owner at that time. The well does not appear in any other lists of spring waters in Excelsior Springs, except for a tabulation of waters in *The Waters of Excelsior Springs*, where it is included with the *soda bicarbonate*. The house was built sometime between 1913 and 1923, as the Sanborns show a different structure on Lot 8, Block 1 of Kugler's Addition. It was demolished during the course of this survey project, and the lot graded in preparation for new construction.
